**Flood Control Project Maintenance
Levee Inspections**

Fall 2010 Levee Maintenance Deficiency Summary Report

Levee Inspection Report By Mile - Fall 2010

Reclamation District No. 2058 Pescadero

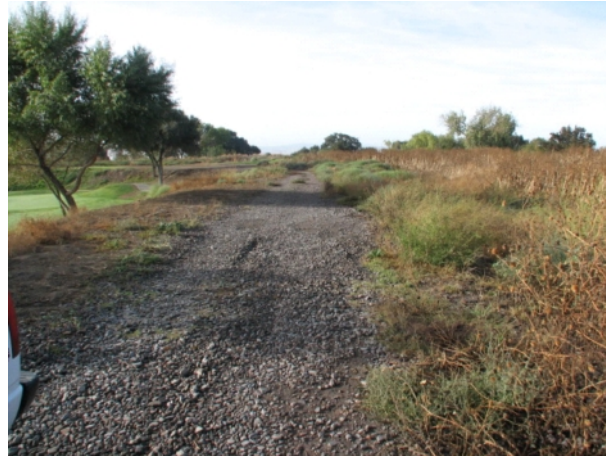
Levee Mile Report Line	1
Start Levee Mile	0.00
End Levee Mile	0.10
Location	Crown
Category	Earthen Levee
Item	Vegetation
Vegetation on the waterside of crown obstructs visibility.	
jpaasch_f_20101029_510.jpg

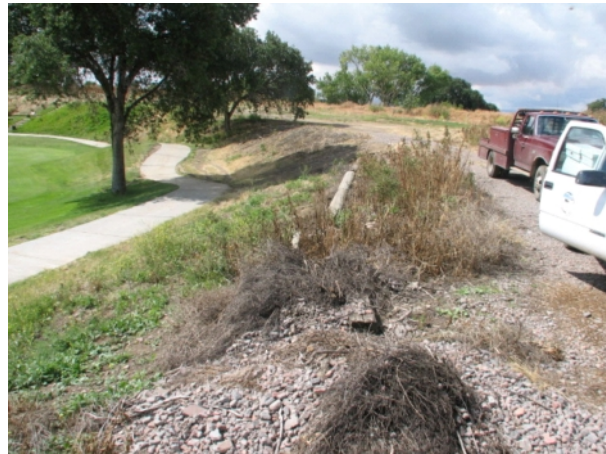
Levee Mile Report Line	2
Start Levee Mile	0.03
End Levee Mile	0.03
Location	Land Side
Category	Earthen Levee
Item	Encroachments
Wood poles, railroad ties and other debris on landside slope appear to prevent access to cart path.	
jpaasch_f_20100923_233.jpg

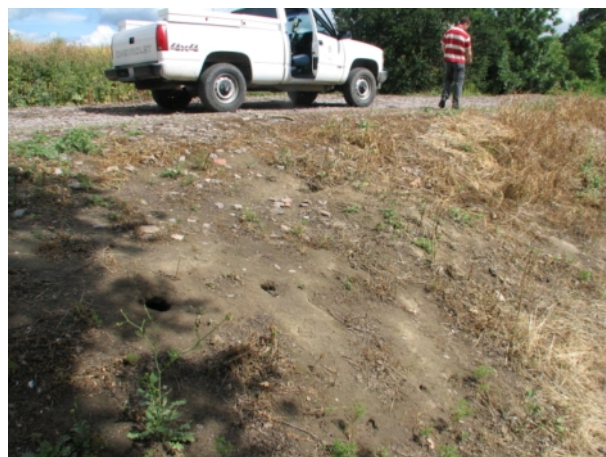
Levee Mile Report Line	5
Start Levee Mile	0.14
End Levee Mile	0.14
Location	Land Side
Category	Earthen Levee
Item	Animal Control
Active animal burrows on landside slope.	
jpaasch_f_20100923_234.jpg

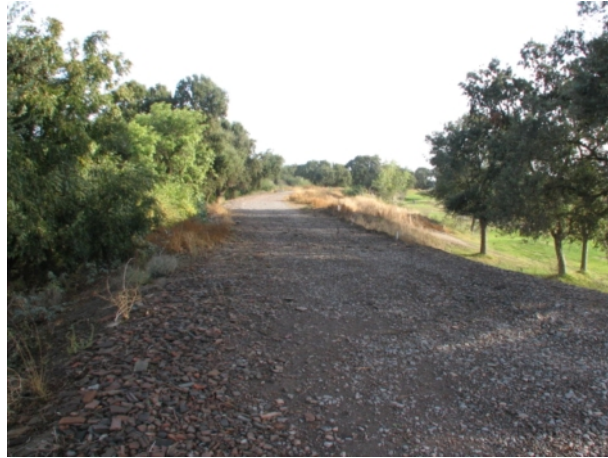
Levee Mile Report Line	6
Start Levee Mile	0.18
End Levee Mile	0.30
Location	Land Side
Category	Earthen Levee
Item	Vegetation

Vegetation on levee slope.

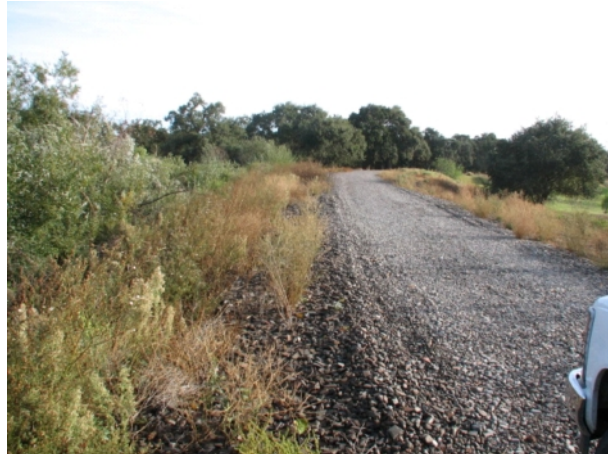
Levee Mile Report Line	9
Start Levee Mile	0.23
End Levee Mile	0.27
Location	Water Side
Category	Earthen Levee
Item	Vegetation

Vegetation on top 20' of waterside levee slope.

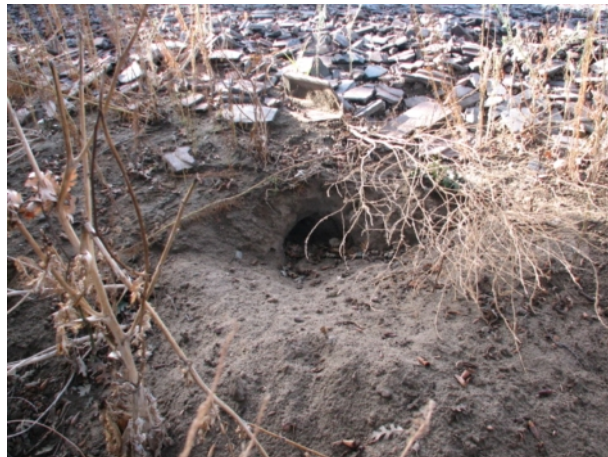
Levee Mile Report Line	11
Start Levee Mile	0.29
End Levee Mile	0.34
Location	Water Side
Category	Earthen Levee
Item	Animal Control

Rodent hole on levee slope near crown.

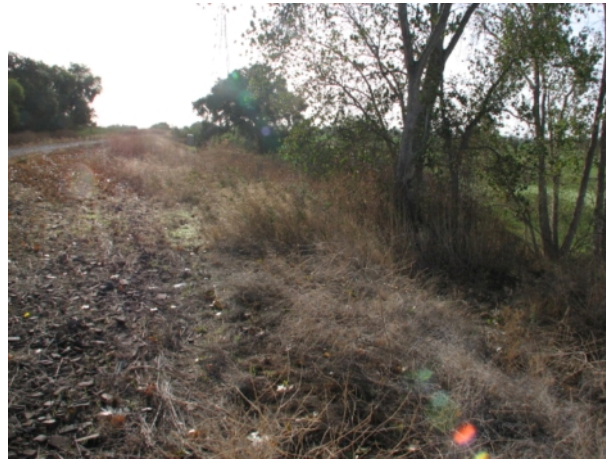
Levee Mile Report Line	12
Start Levee Mile	0.36
End Levee Mile	0.44
Location	Land Side
Category	Earthen Levee
Item	Vegetation

Photo of brush and weeds on landside levee slope and toe.

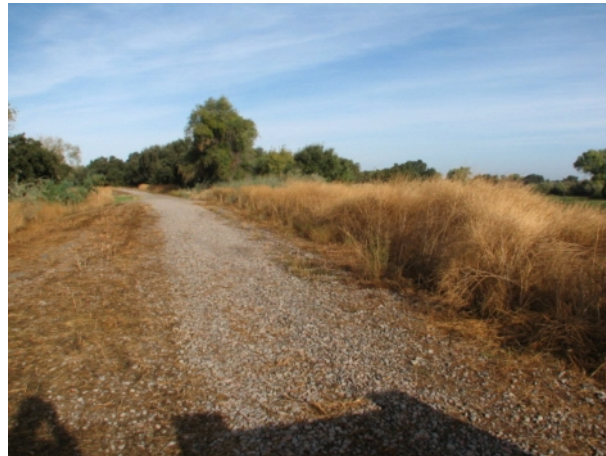
Levee Mile Report Line	13
Start Levee Mile	0.41
End Levee Mile	0.52
Location	Water Side
Category	Earthen Levee
Item	Vegetation

Tall weeds on waterside levee slope obstruct access and visibility.

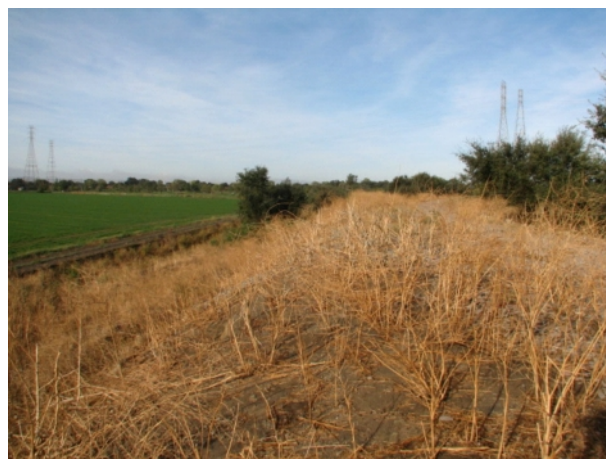
Levee Mile Report Line	14
Start Levee Mile	0.53
End Levee Mile	1.80
Location	Land Side
Category	Earthen Levee
Item	Vegetation

Tall stems from mustard weed remain on levee slope and toe.

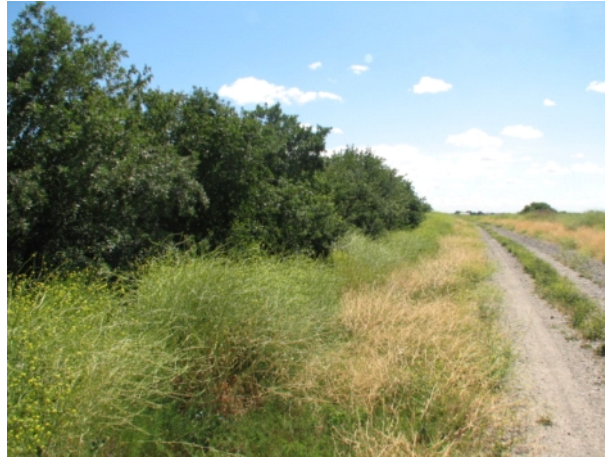
Levee Mile Report Line	15
Start Levee Mile	0.82
End Levee Mile	0.93
Location	Water Side
Category	Earthen Levee
Item	Trim / Thin Trees

Dense trees on waterside slope obstruct access and visibility.

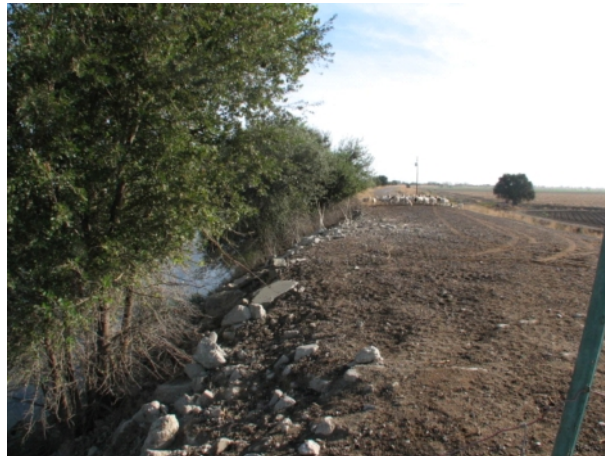
Levee Mile Report Line	16
Start Levee Mile	0.93
End Levee Mile	1.14
Location	Crown
Category	Earthen Levee
Item	Vegetation

Grazing by goats has improved access and visibility at this location.

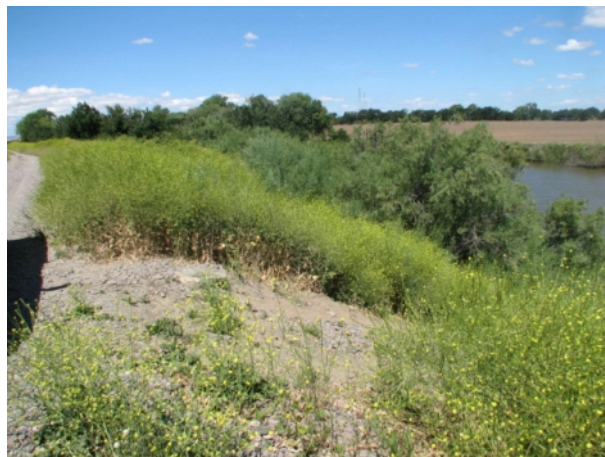
Levee Mile Report Line	19
Start Levee Mile	1.22
End Levee Mile	1.22
Location	Water Side
Category	Earthen Levee
Item	Vegetation

Dense brush on top 20' of waterside slope obstructs access and visibility.

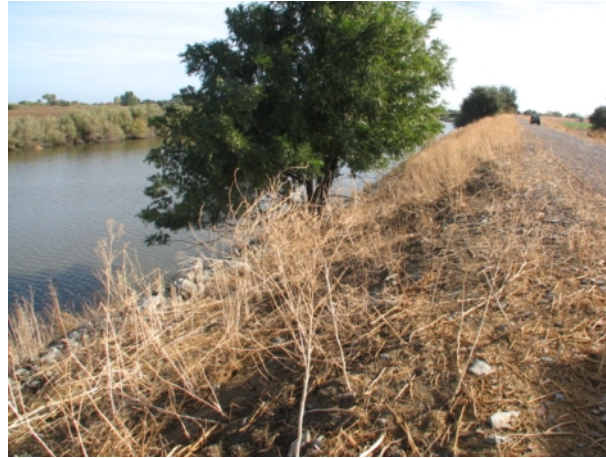
Levee Mile Report Line	19
Start Levee Mile	1.22
End Levee Mile	1.22
Location	Water Side
Category	Earthen Levee
Item	Vegetation

Grazing of vegetation on waterside slope has improved access and visibility. Tall stems remain.

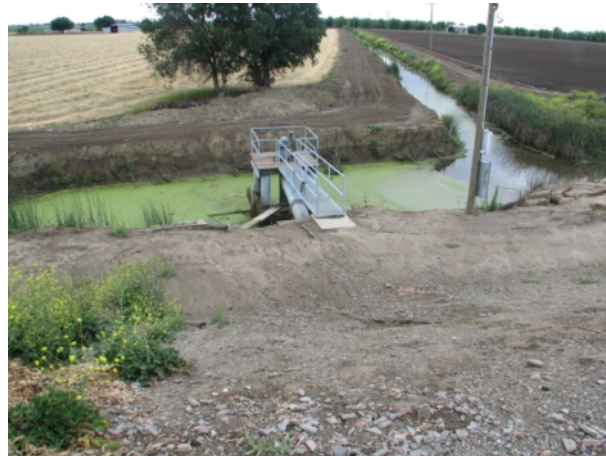
Levee Mile Report Line	20
Start Levee Mile	1.24
End Levee Mile	1.24
Location	Crown
Category	Earthen Levee
Item	Encroachments

Drainage discharge to Paradise Cut.

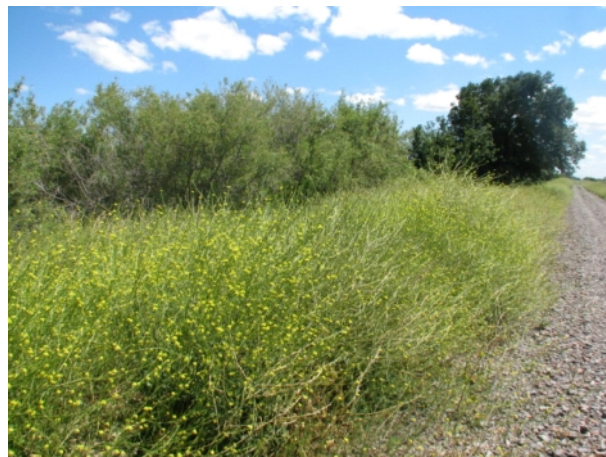
Levee Mile Report Line	22
Start Levee Mile	1.30
End Levee Mile	1.30
Location	Water Side
Category	Earthen Levee
Item	Vegetation

22	1.30	1.30	Earthen Levee	Vegetation	WS	M	Remove the wild growth other than native grasses from the levee slopes. Inspector Comments: Removal of his type of vegetation has been prohibited due to FWS concerns with RBR. Grazing has improved visibility.	37.802581 ° -121.400861 °	37.802581 ° -121.400861 °	15 Y
23	1.34	1.34	Earthen Levee	Vegetation	WS	M	Remove the wild growth other than native grasses from the levee slopes. Inspector Comments: Removal of this type of vegetation is currently prohibited by FWS due to concerns with RBR. Grazing has improved visibility.	37.802743 ° -121.400188 °	37.802743 ° -121.400188 °	959 Y
24	1.35	1.38	Earthen Levee	Vegetation	WS	M	Remove the wild growth other than native grasses from the levee slopes. Inspector Comments: Removal of this type of vegetation is currently prohibited by FWS due to concerns with RBR. Grazing has improved visibility.	37.802737 ° -121.400201 °	37.802886 ° -121.399551 °	16

Tall brush on top 20' of waterside slope obstructs access and visibility.

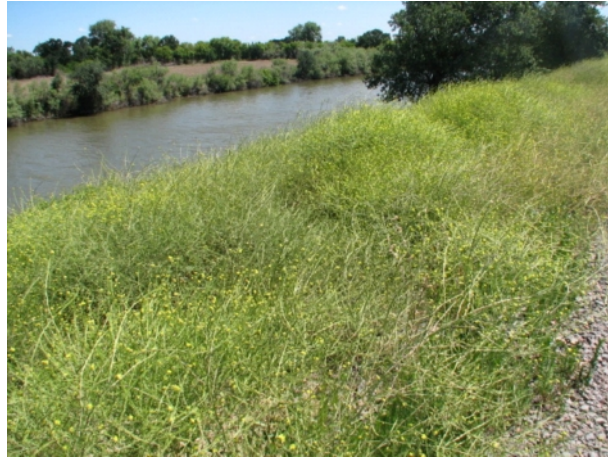
Levee Mile Report Line	23
Start Levee Mile	1.34
End Levee Mile	1.34
Location	Water Side
Category	Earthen Levee
Item	Vegetation

Tall brush on top 20' of waterside slope obstructs access and visibility.

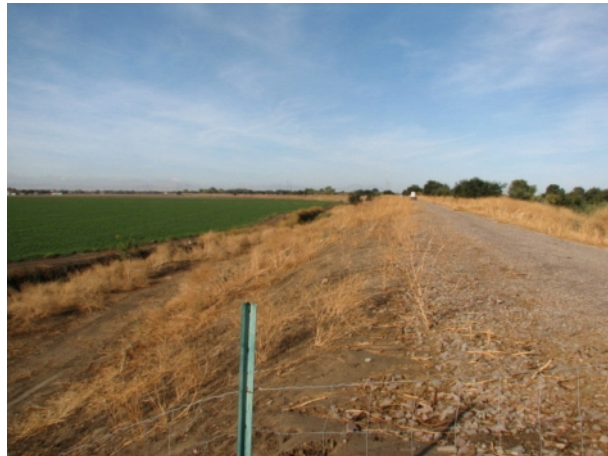
Levee Mile Report Line	28
Start Levee Mile	1.80
End Levee Mile	2.15
Location	Land Side
Category	Earthen Levee
Item	Vegetation

Grazed levee slope at levee mile 2.15 looking downstream towards 1.80. Stems of mustard weed remain on the slopes and obstruct access and visibility.

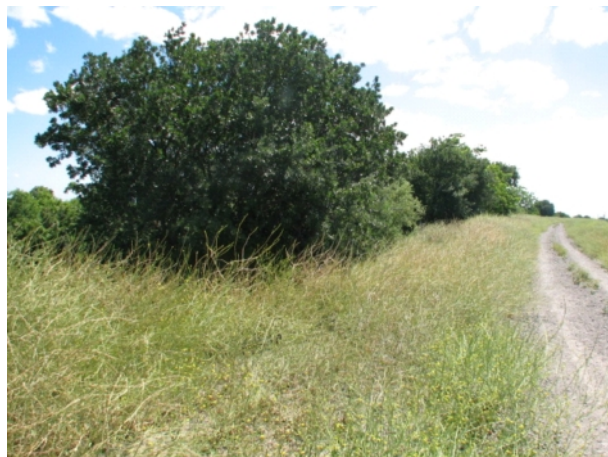
Levee Mile Report Line	29
Start Levee Mile	1.89
End Levee Mile	1.92
Location	Water Side
Category	Earthen Levee
Item	Trim / Thin Trees

29	1.89	1.92	Earthen Levee	Trim / Thin Trees	WS	U	Trim trees to at least five feet above ground level. Inspector Comments: Minimal pruning and no removal allowed by FWS because of RBR.	37.804783 ° -121.390579 °	37.804720 ° -121.390123 °	963 Y
30	1.99	2.03	Earthen Levee	Trim / Thin Trees	WS	M	Trim trees to at least five feet above ground level. Inspector Comments: Minimal pruning and no removal allowed by FWS because of RBR.	37.804497 ° -121.388905 °	37.804350 ° -121.388252 °	964
31	2.15	2.15	Supplemental	DWR Erosion Survey	WS	M	Inspector Comments: 09/22/2010: No significant changes observed. Vegetation downstream, upstream and on the lower slope of the site have been recently sprayed. These areas were also fenced off during the site visit, making it difficult for us to examine the condition of the lower slope. Possible leak or spill from the siphon breaker is creating notches along the slope and developing into a headward erosion. If the problem continues, it will erode the slope and fully expose the pipe to outside elements. [2010 SiteID: RD2058U01RM1.78]	37.803769 ° -121.386341 °	37.803769 ° -121.386341 °	2 Y

Dense trees on top 20' of waterside slope obstructs access and visibility.

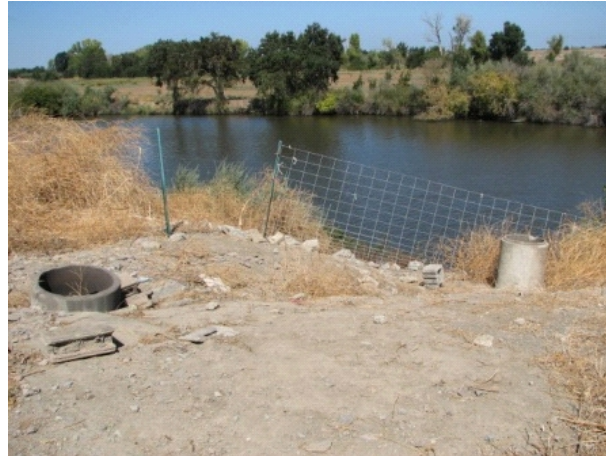
Levee Mile Report Line	31
Start Levee Mile	2.15
End Levee Mile	2.15
Location	Water Side
Category	Supplemental
Item	DWR Erosion Survey

Downstream view of site. Note the fenced area

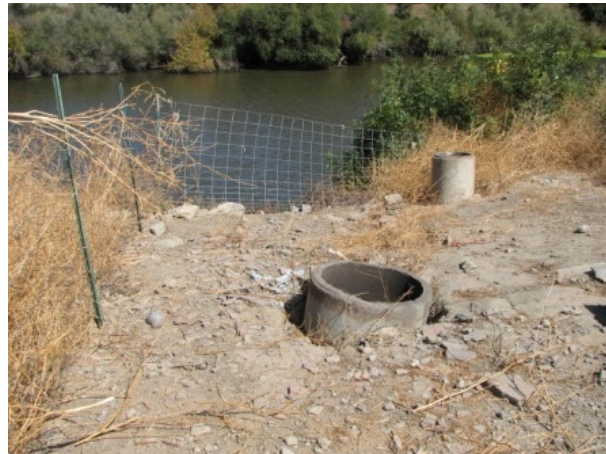
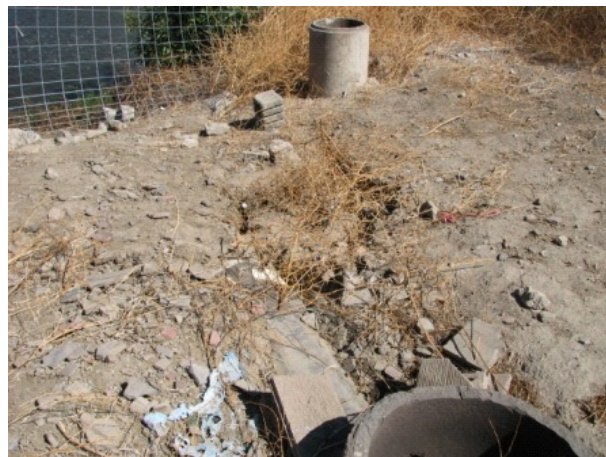
Levee Mile Report Line	31
Start Levee Mile	2.15
End Levee Mile	2.15
Location	Water Side
Category	Supplemental
Item	DWR Erosion Survey

Direct view of siphon breaker.

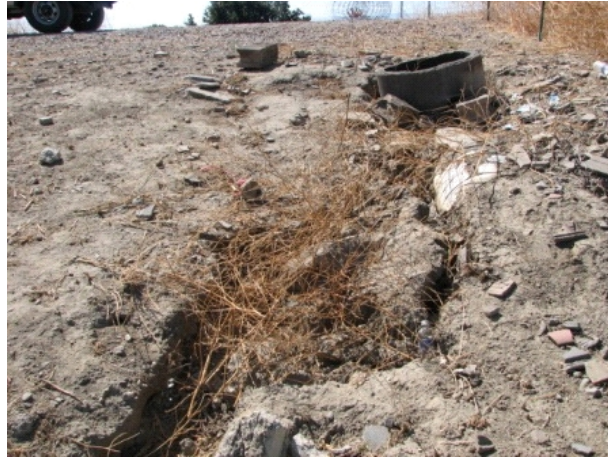
Levee Mile Report Line	31
Start Levee Mile	2.15
End Levee Mile	2.15
Location	Water Side
Category	Supplemental
Item	DWR Erosion Survey

Notches created by water leaking/overflowing from the siphon breaker.

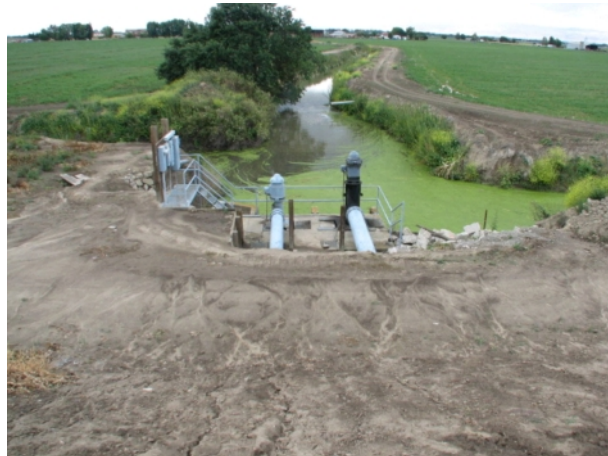
Levee Mile Report Line	32
Start Levee Mile	2.15
End Levee Mile	2.15
Location	Crown
Category	Earthen Levee
Item	Encroachments

Drainage discharge to Paradise Cut.

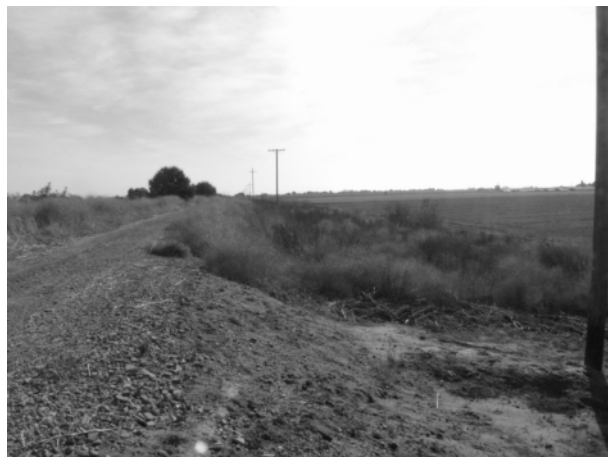
Levee Mile Report Line	33
Start Levee Mile	2.15
End Levee Mile	3.10
Location	Land Side
Category	Earthen Levee
Item	Vegetation

Dried weeds on landside levee slope and toe obstruct access and visibility.

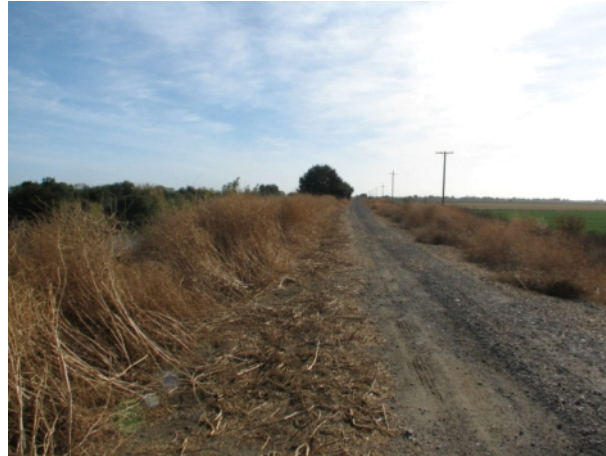
Levee Mile Report Line	34
Start Levee Mile	2.15
End Levee Mile	3.10
Location	Water Side
Category	Earthen Levee
Item	Vegetation
Dried weeds on waterside slope obstruct access and visibility.	
jpaasch_f_20101101_524.jpg

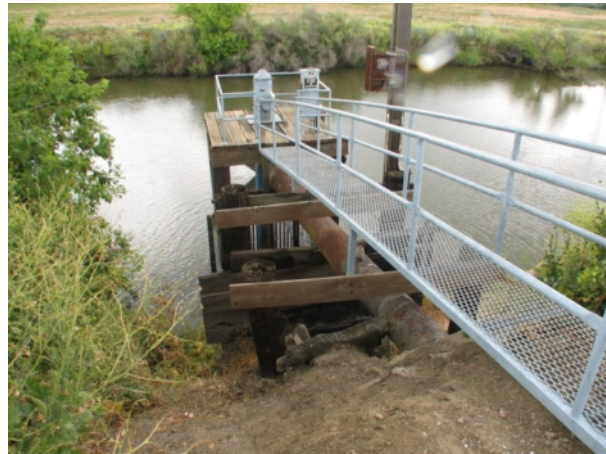
Levee Mile Report Line	36
Start Levee Mile	2.89
End Levee Mile	2.89
Location	Water Side
Category	Earthen Levee
Item	Encroachments
Irrigation intake from Paradise Cut.	
jpaasch_f_20100923_239.jpg

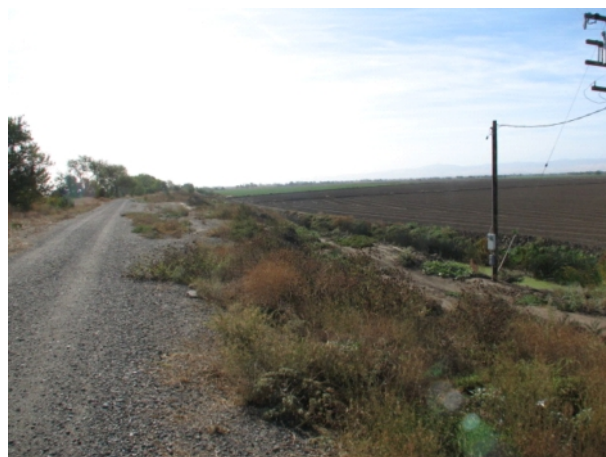
Levee Mile Report Line	37
Start Levee Mile	3.13
End Levee Mile	5.98
Location	Land Side
Category	Earthen Levee
Item	Vegetation
Tall weeds on landside levee slope and toe obstruct visibility.	
jpaasch_f_20101101_526.jpg

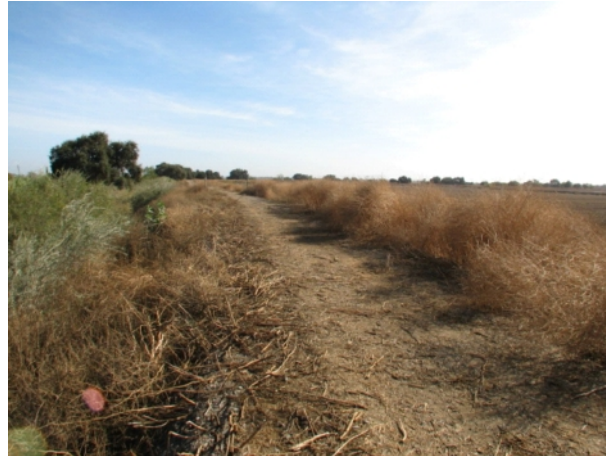
Levee Mile Report Line	37
Start Levee Mile	3.13
End Levee Mile	5.98
Location	Land Side
Category	Earthen Levee
Item	Vegetation
Dried weeds on levee slope obstruct access and visibility.	
jpaasch_f_20101101_527.jpg

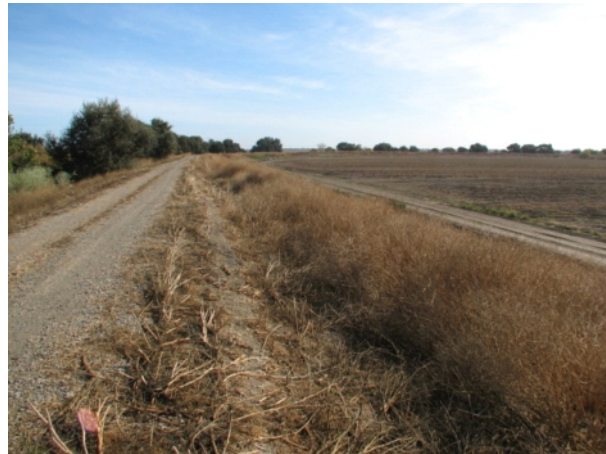
Levee Mile Report Line	37
Start Levee Mile	3.13
End Levee Mile	5.98
Location	Land Side
Category	Earthen Levee
Item	Vegetation
Dried weeds on levee slope and toe obstruct access and visibility.	
jpaasch_f_20101101_529.jpg

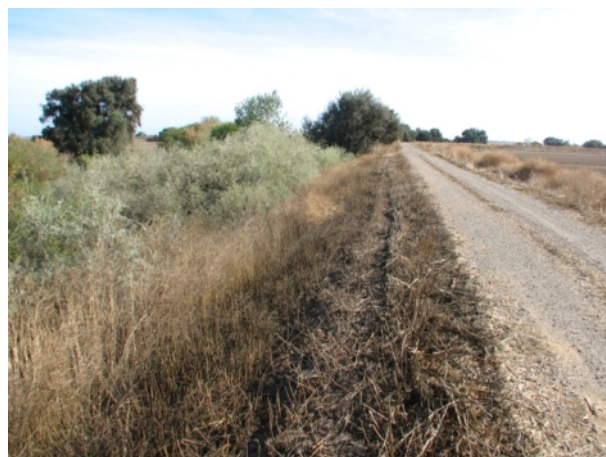
Levee Mile Report Line	38
Start Levee Mile	3.13
End Levee Mile	5.98
Location	Water Side
Category	Earthen Levee
Item	Vegetation
Brush on waterside slope obstructs access and visibility.	
jpaasch_f_20101101_522.jpg

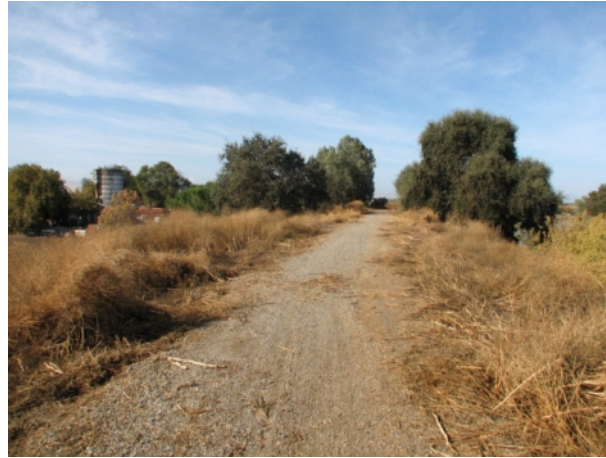
Tall weeds on landside levee slope obstructs access and visibility.

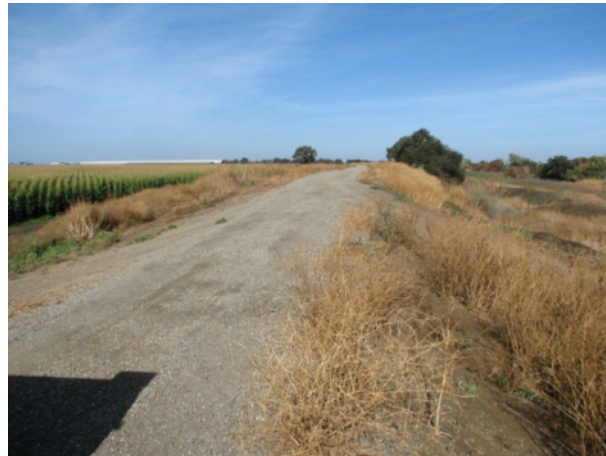
Levee Mile Report Line	38
Start Levee Mile	3.13
End Levee Mile	5.98
Location	Water Side
Category	Earthen Levee
Item	Vegetation

Dried weeds on levee slope obstruct visibility.

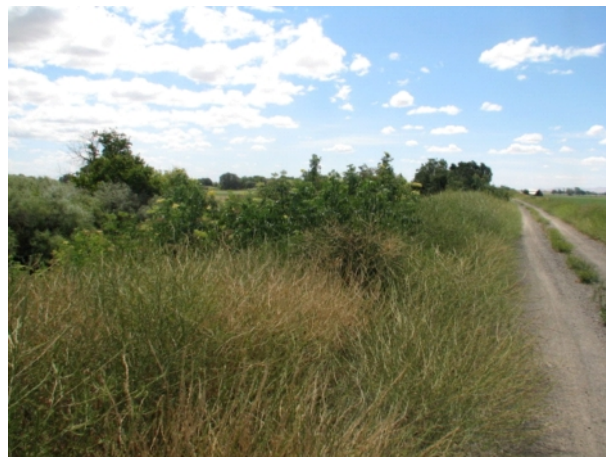
Levee Mile Report Line	42
Start Levee Mile	3.77
End Levee Mile	3.77
Location	Water Side
Category	Earthen Levee
Item	Vegetation

Tall brush on top 20' of waterside slope obstructs access and visibility.

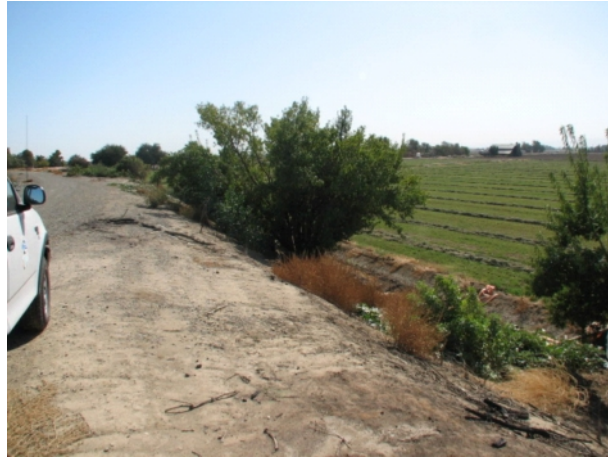
Fall 2009 photo of trees needing trimming to allow access and visibility.

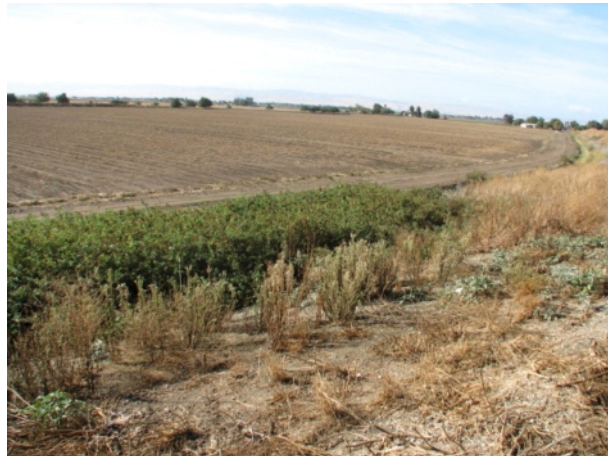
Levee Mile Report Line	49
Start Levee Mile	4.46
End Levee Mile	4.46
Location	Land Side
Category	Earthen Levee
Item	Vegetation

Wild rose on levee toe and slope obstructs access and visibility.

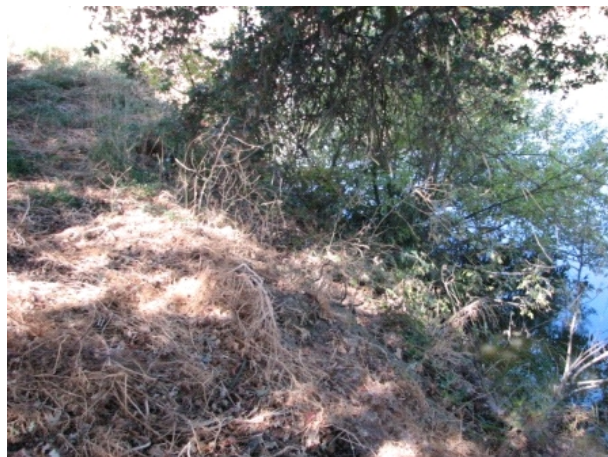
Levee Mile Report Line	50
Start Levee Mile	4.49
End Levee Mile	4.53
Location	Water Side
Category	Supplemental
Item	DWR Erosion Survey

Downstream view. Seasonal vegetation covering one of several pocket erosions lined along the bank.

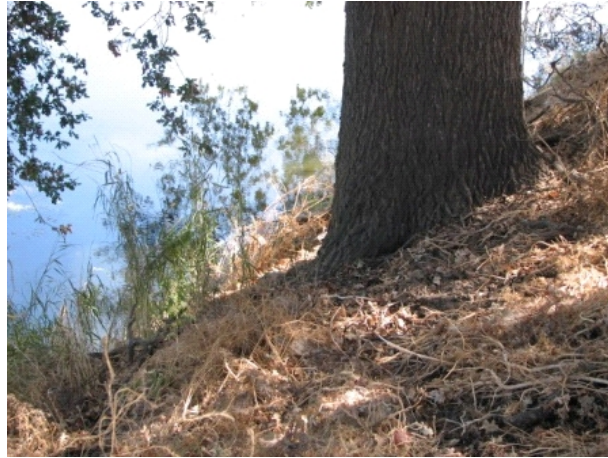
Upstream view of the base of 1 of 2 large Oake trees on site. No signs of scouring on the base.

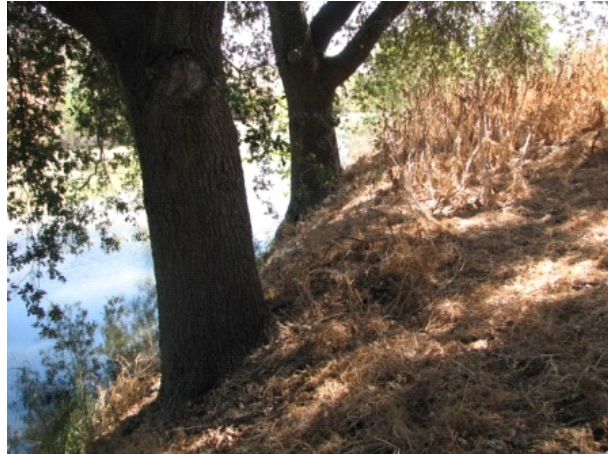
Levee Mile Report Line	50
Start Levee Mile	4.49
End Levee Mile	4.53
Location	Water Side
Category	Supplemental
Item	DWR Erosion Survey

Upstream view of both Oak trees located on the bench.

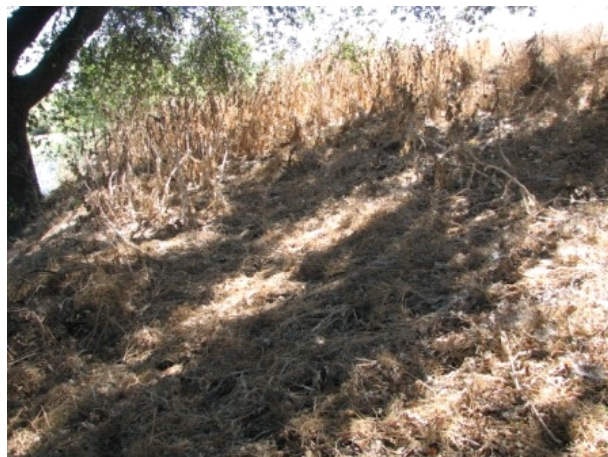
Levee Mile Report Line	50
Start Levee Mile	4.49
End Levee Mile	4.53
Location	Water Side
Category	Supplemental
Item	DWR Erosion Survey

Upstream view of the waterside slope. Vegetation on the slope was recently sprayed.
